Manhole Inspection Summary

Manhole # S69A1_010MH

Location Address: **2200 Van Deman St.**

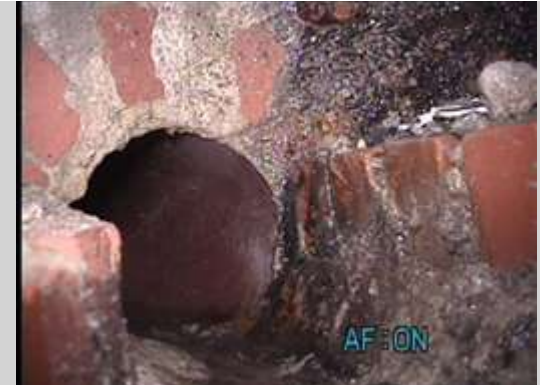
12 O'Clock Outflow

8 in. Circular Gravity Sewer
Pipe Out @ 12 O'Clock

Pipe Height: **8.4** (in.) Rod and Bar (Angled)

Infiltration: **None** Pipe Seal Cond: **Sound**
